Operating Experience from Early-Stage Nuclear Plant Failures

June 2026

BNPP IAMP Presentation Content

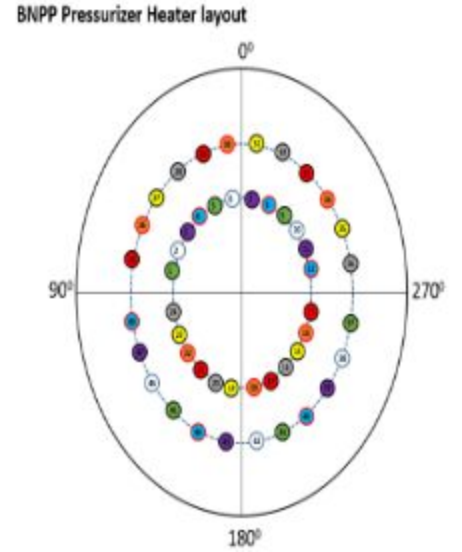
Heater P2-31

Heater Seath Failures

Seath is made of SS 316 grade. BNPP has seen few failures in past on the heater Seath cracking - IGSCC.

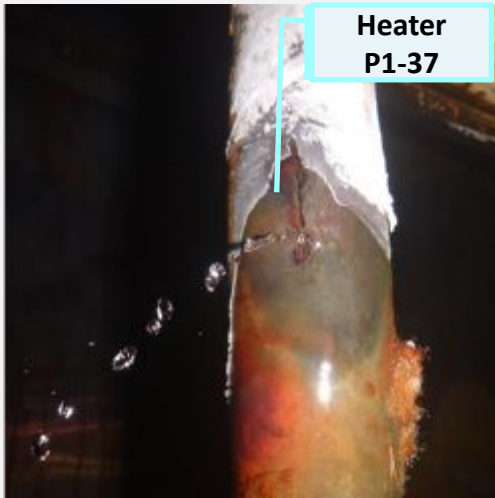
Heater P1-37

Heater Sleeve Failures

PZR Heater Sleeve - Inconel 690 TT material.

OE- 02 Sleeve failures

Creep damage - Localized heat source inside the cold section of the heater due to element melting in the hot section.

PREVENTION
<ul style="list-style-type: none"> Faulted heater isolated to prevent any further fault progression that could result in RCS leakage. Replacement of heaters with improved design when failed to prevent reoccurrence. Project ongoing to develop new heater design that eliminates RCS leakage risks.

DETECTION
<ul style="list-style-type: none"> Effective implementation of the Adverse Condition Monitoring Plan (ACMP) to detect ground faults and current changes. Thorough investigation and troubleshooting to identify faulted heater. Sharing of lessons learned with other Ops crews to help recognition.

CORRECTION
<ul style="list-style-type: none"> Operational Decision Making Process used for structured assessment of risk and forward actions. Faulted heater identified and isolated to stop fault progression and restore margin to the Operators.

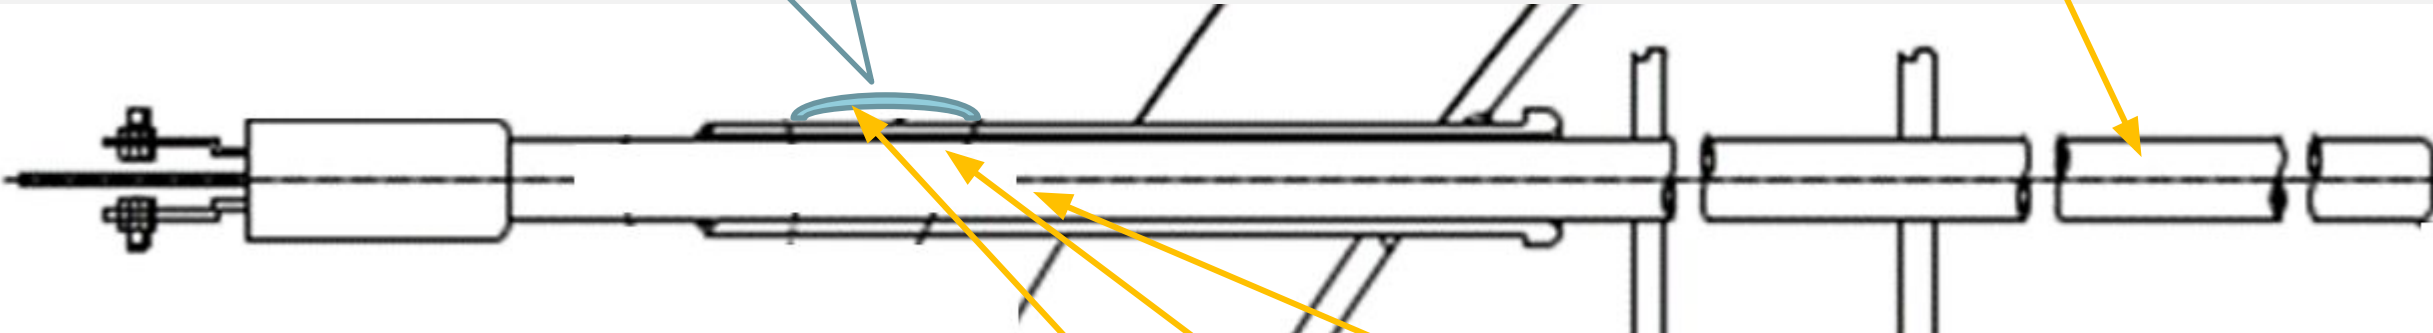
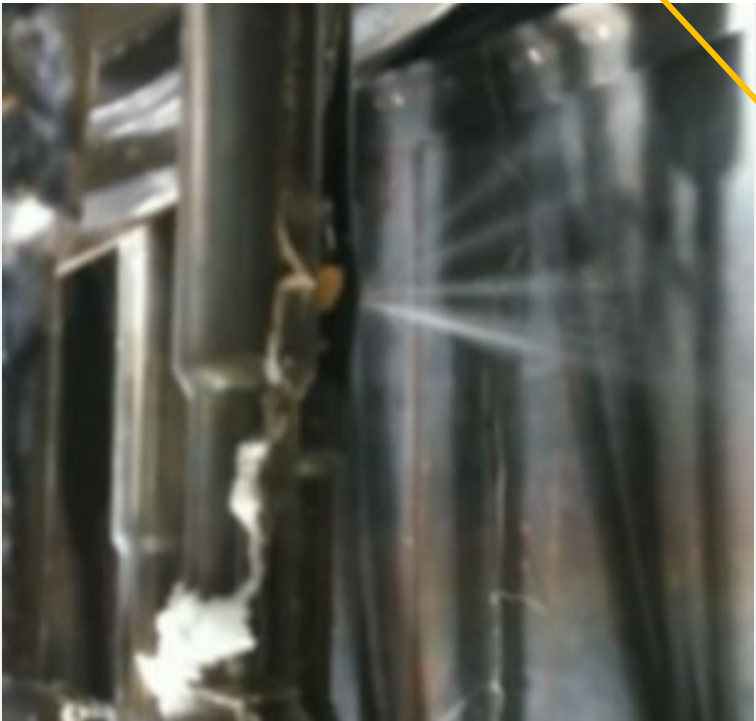
Leakage position

1st Stage :Some of 3 sets of heater elements failed

2nd Stage :As a result of the element failures, 2 of 6 Ni conduit wires carried the full current and overheated

3rd Stage : 316L Stainless steel Sheath overheated 715°C <Temp >870°C; Time>2000h Mostly σ -phase precipitated

4th Stage : Inconel 690 Sleeve exposed to Creep temperature range and time whilst operating @155Bar – Temp >700 °C - 850°C; Creep Time<2900h
FINAL FAILURE CAUSING THE LEAK
THIS MECHANISM HAS NOT BEEN RECORDED IN INDUSTRY

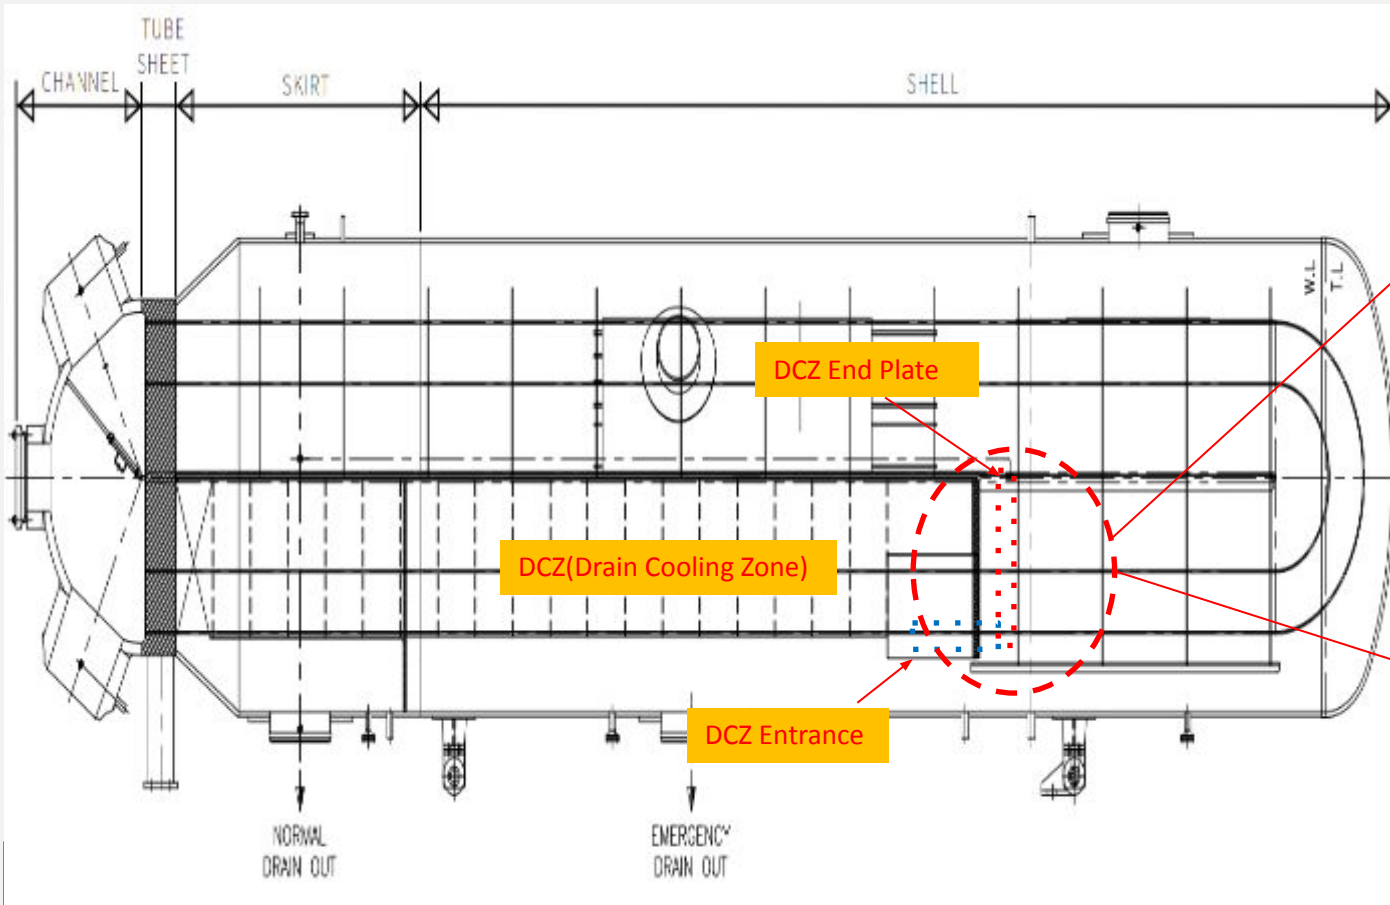
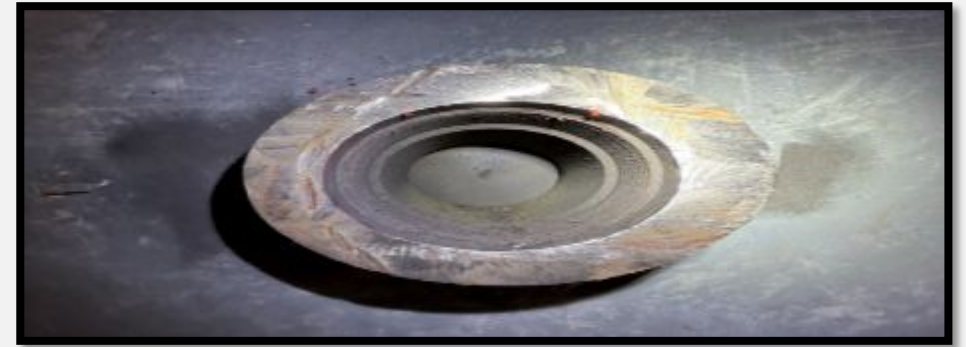
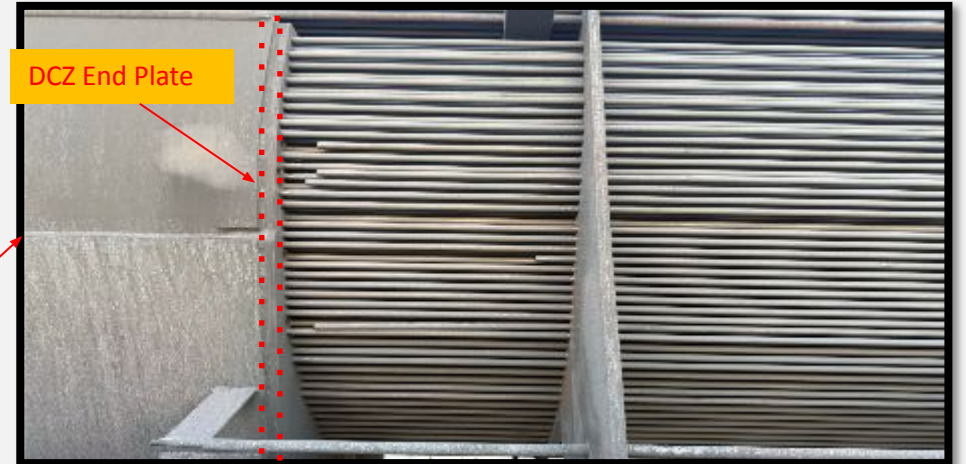
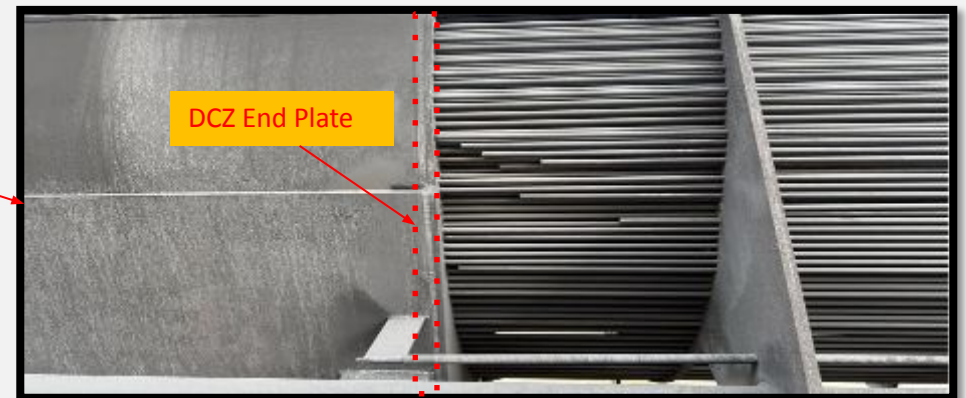
All sheared tubes were found around the end plate of the DCZ, and based on the appearance of the fracture surfaces, the failure appears to be fatigue failure caused by vibration near the DCZ entrance. It was confirmed that the hole of the upper pressure measurement nozzle on the shell, which is used for level measurement, was blocked inside the shell by a plate

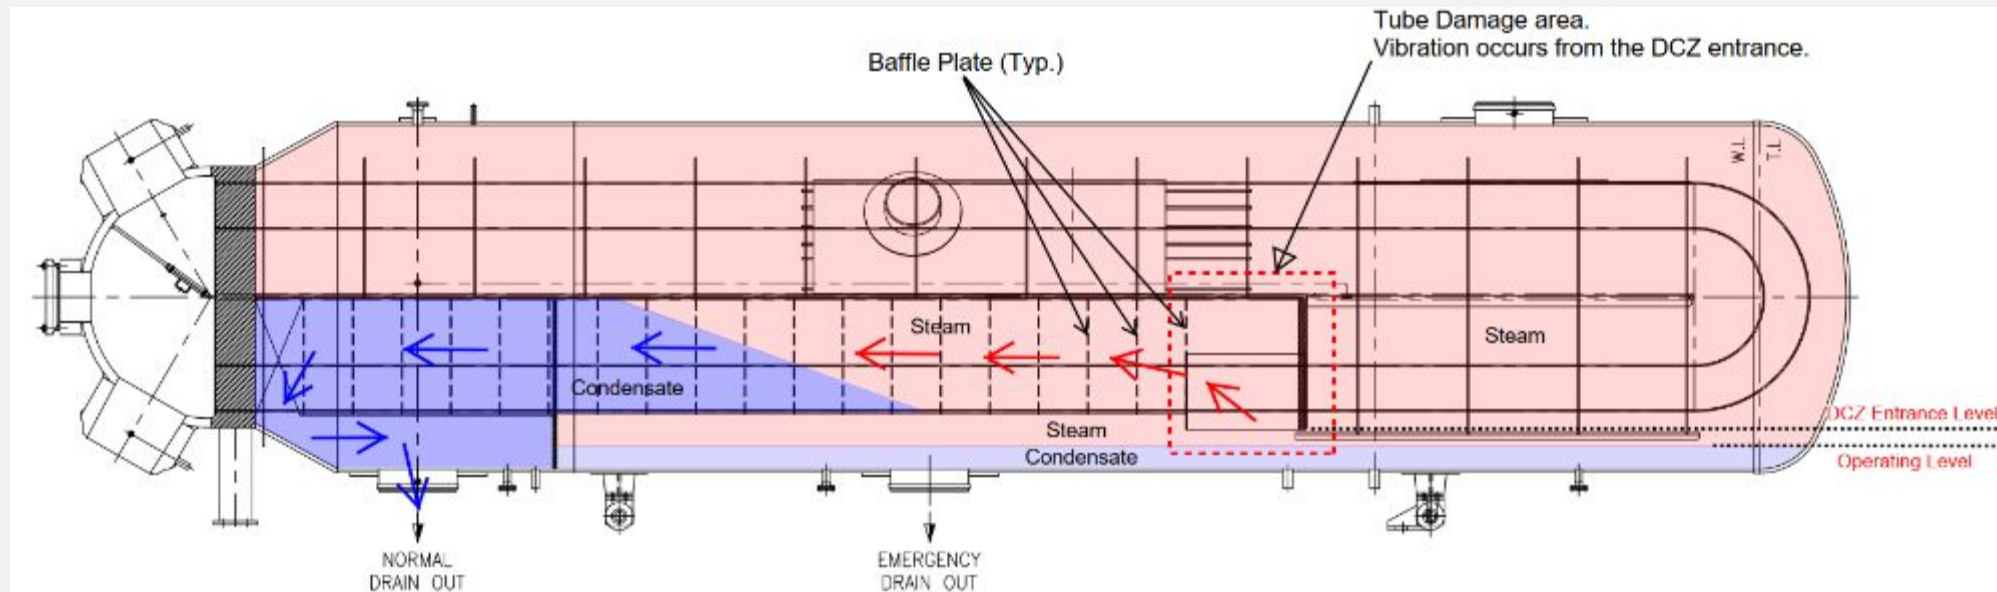
It is presumed that the HTR was operated for an extended period with the water level lower than the DCZ entrance, allowing a large amount of steam to flow into the Drain Cooling Zone (DCZ). Since steam is in a gaseous state and has a larger volume than condensate, the inflow of a large amount of steam increases the steam flow velocity in the DCZ. This increased velocity induces tube vibration, and the continuous vibration is believed to have caused damage to the tubes around the DCZ end plate.

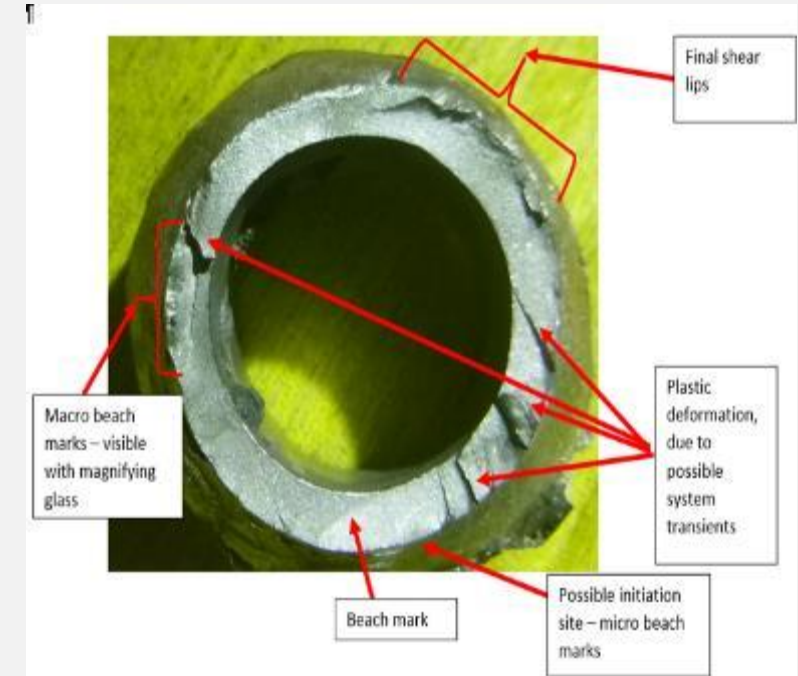
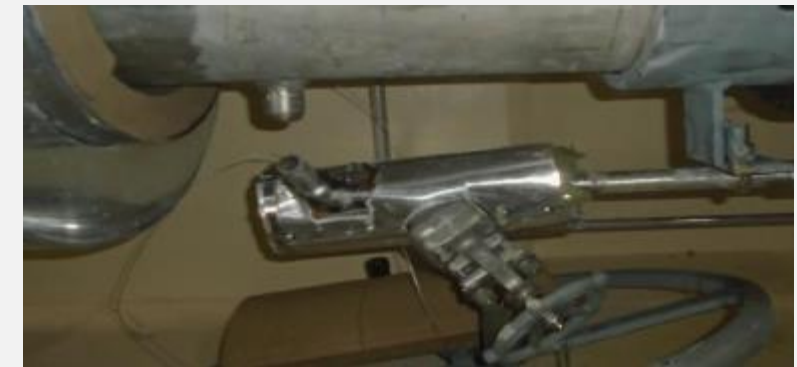
¾" socket weld, **Shutdown Cooling Drain Line**, near HEX throttling valve

- **High-cycle fatigue (HCF)** induced by pipe vibration
- Vibration source: **Valve throttling of SCS heat exchanger control valve**
- Crack initiated at **outside diameter (OD)**

- Presence of **fatigue striations / beach marks** on fracture surface
- Crack propagation consistent with **cyclic loading mechanism**

- **Flow-induced vibration** due to excessive valve throttling
- Susceptibility of **socket weld geometry** to stress concentration under dynamic loading

- **Operational control:** Limit/control valve throttling range
- **Design improvement:** Socket weld enhancement in line with EPRI guidance

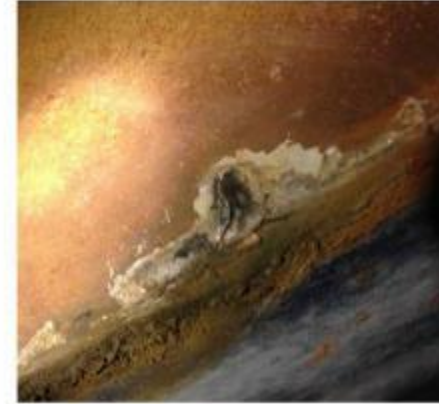
Spool No. : 2-462-P-SX004-811

Damaged Lining Parts inside Spools

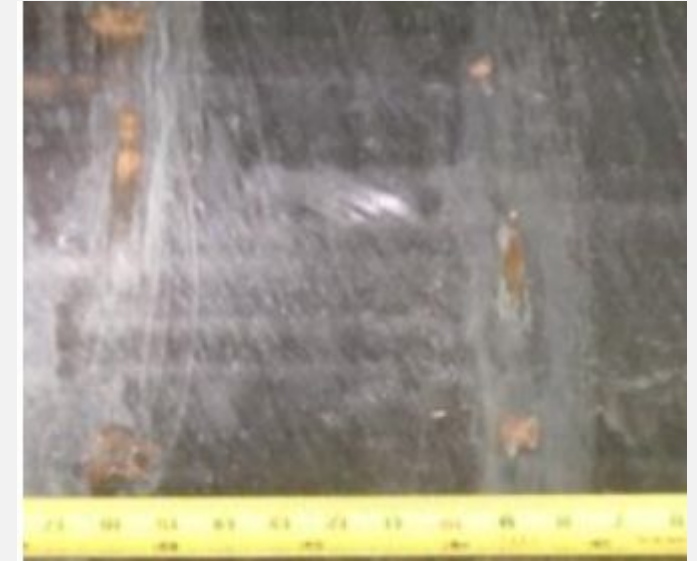
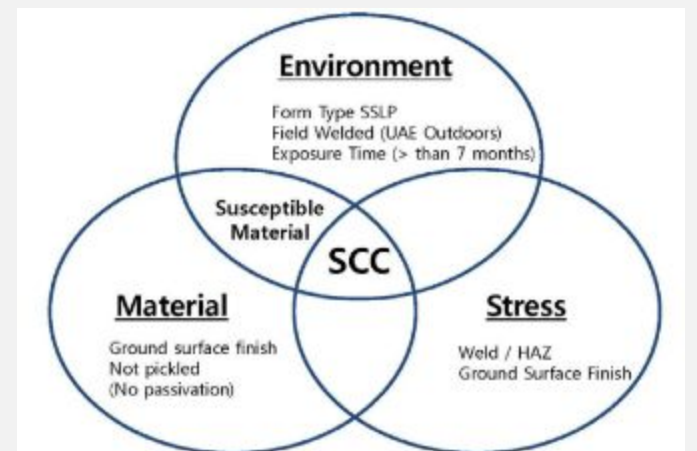
- Spent Fuel Pool and IRWST Liner plates made of **Stainless-Steel SS 304**
- Most of the defects found on **weld seam and Heat Affected Zone (HAZ)**, not on base material.

- Cracking at the main seam welding of Liner plates
- Identified during the construction phase

- Cracking at main seam welding identified during penetrant testing.
- Replica test results showed cracks with branching characteristic of **stress corrosion cracking (SCC)**

- Chloride induced Stress Corrosion Cracking (**CL SCC**)
- Prolonged exposure to aggressive marine environment and inadequate cleanliness requirements.
- Main Factors – Salte-laden atmosphere, Dust, high humidity etc.

- Repaired all the defects during the construction and verified with required testing.
- The liner plates are installed in controlled environment.
