Operating Experience from Early-Stage Nuclear Plant Failures

June 2026

BNPP IAMP Presentation Content

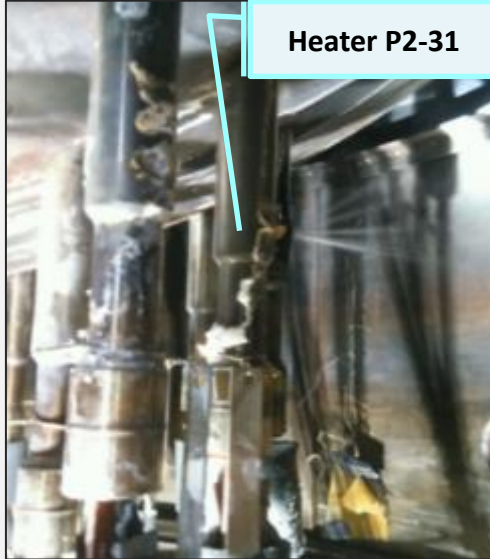
Heater P2-31

Heater Seath Failures

Seath is made of SS 316 grade. BNPP has seen few failures in past on the heater Seath cracking - IGSCC.

Heater Sleeve Failures

PZR Heater Sleeve - Inconel 690 TT material.

OE- 02 Sleeve failures

Creep damage - Localized heat source inside the cold section of the heater due to element melting in the hot section.

PREVENTION
<ul style="list-style-type: none"> Faulted heater isolated to prevent any further fault progression that could result in RCS leakage. Replacement of heaters with improved design when failed to prevent reoccurrence. Project ongoing to develop new heater design that eliminates RCS leakage risks.

DETECTION
<ul style="list-style-type: none"> Effective implementation of the Adverse Condition Monitoring Plan (ACMP) to detect ground faults and current changes. Thorough investigation and troubleshooting to identify faulted heater. Sharing of lessons learned with other Ops crews to help recognition.
